GLENN L. SMITH, P.E.
Consulting Engineer, P.C.

March 16, 2017

Re: Schreiber Bungalows / Gamble Estates
Project, Gamble Road & NYS Route 42,
(T) Fallsburg

A site inspection was performed at the above noted property on March 8, 2017 for the purpose of generally determining the overall structural, maintenance and safety conditions of 24 seasonal housing units situated in ten (10) separate buildings. As you know, the current count will be reduced to 20 units by converting one (1) quad and two (2) triplex buildings into duplexes.

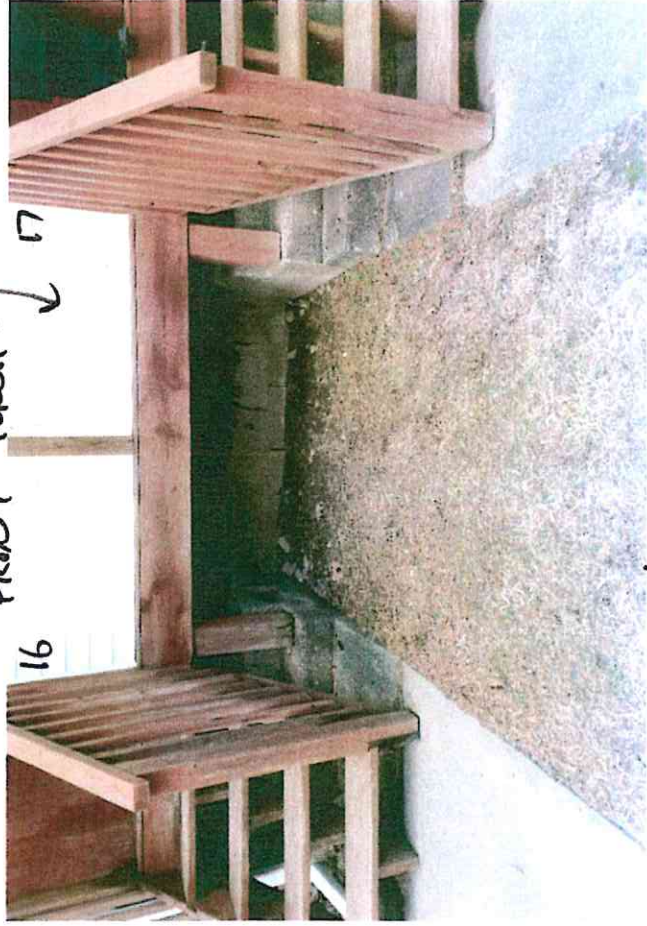
UNITS 16/17

Duplex Unit #16/17 – Both units contain two bedrooms and a single bathroom. Crawlspace framing consists of 6" x 6" P.T. wood piers set on 2' x 2' concrete footing pads on grade, it appears that the building is periodically leveled to address for seasonal frost heave. There is an original concrete block porch foundation that exists below the front porch in the crawlspace area, although the current building was basically constructed over that structure with only two front 6" x 6" wood support piers at the porch set on the original concrete steps. The crawlspace wood framing appears to be in satisfactory condition and solid.

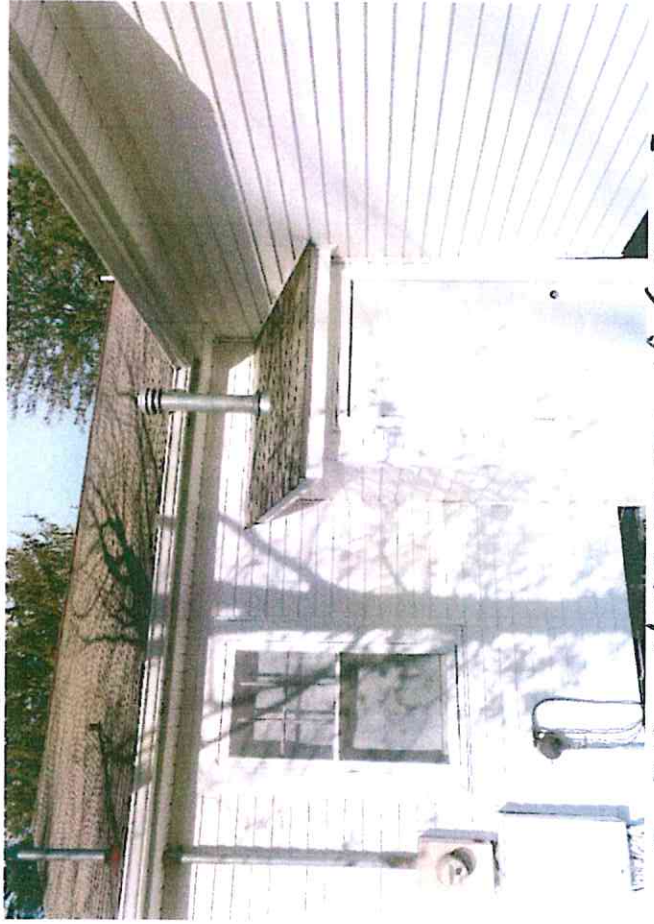
TYPICAL H.W. HEAT-CLOSED - REAR OF QUAD UNITS 3/4/5/6

In addition, many of the heater vent flues terminate either below or slightly above the adjacent building roof eaves, which is in violation of code section G2427.6.3, "Gas Vent Terminations". Since the flues are less than 8 ft. horizontal distance from the adjacent vertical wall of the building it serves, a minimum 24" vertical clearance is required to roofline. These modifications should be made where required.

The rear hot water heater gas exhaust flue cap terminates 6" above the roof eave, this must be extended to a minimum of 24".

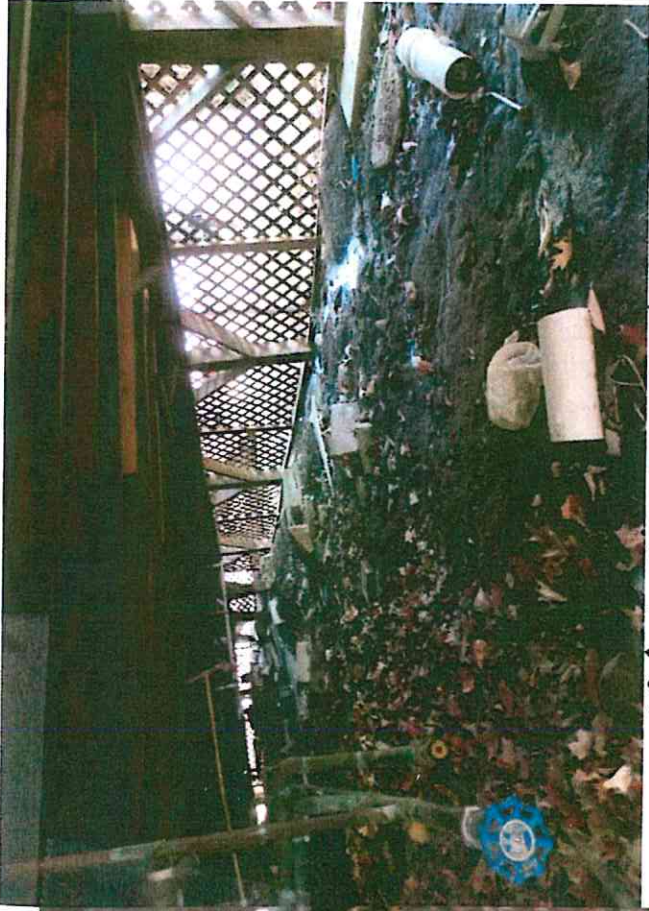
CRAWLSPACE UNITS 7/8/9

Triplex Unit #7/8/9 – This single story structure is also constructed on wood posts and bracing in the crawlspace area that set primarily on concrete footing pads. The soils in this area of the colony are somewhat wet and there is evidence of prior years of frost heave that has occurred as evidenced by some wood posts being slightly out of plumb. Evidence of heave is also found on the floors in the building which are up to ½" out of level in places.

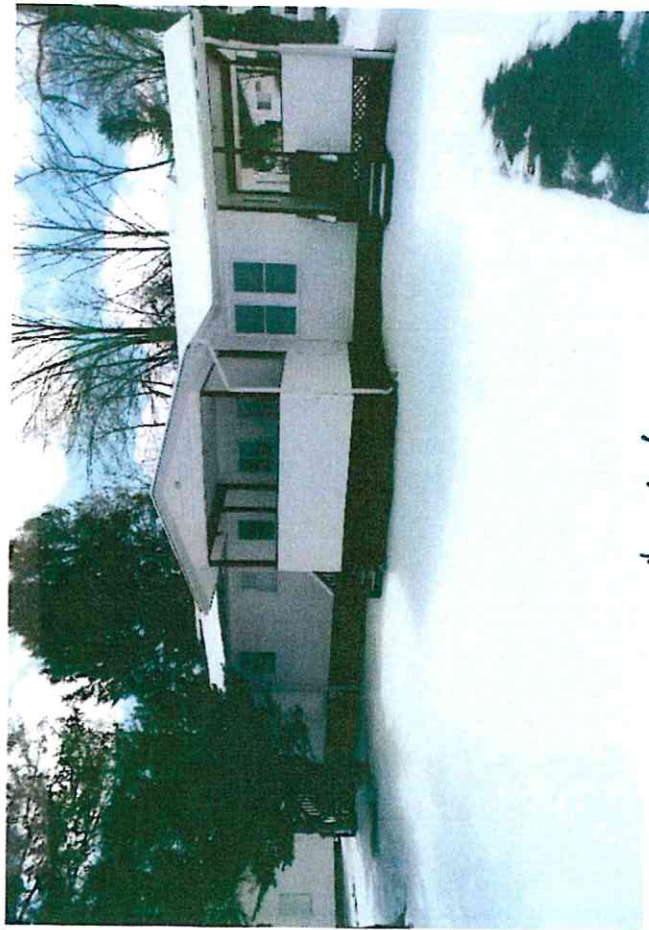
TRIPLEX # 7/8/9

The gas exhaust flue on the hot water heater in the rear closet requires an extension above the adjacent roof eave, the cap is currently below the eave elevation.
