GLENN L. SMITH, P.E.
Consulting Engineer, P.C.

March 16, 2017

Re: Schreiber Bungalows / Gamble Estates
Project, Gamble Road & NYS Route 42,
(T) Fallsburg

A site inspection was performed at the above noted property on March 8, 2017 for the purpose of generally determining the overall structural, maintenance and safety conditions of 24 seasonal housing units situated in ten (10) separate buildings. As you know, the current count will be reduced to 20 units by converting one (1) quad and two (2) triplex buildings into duplexes.

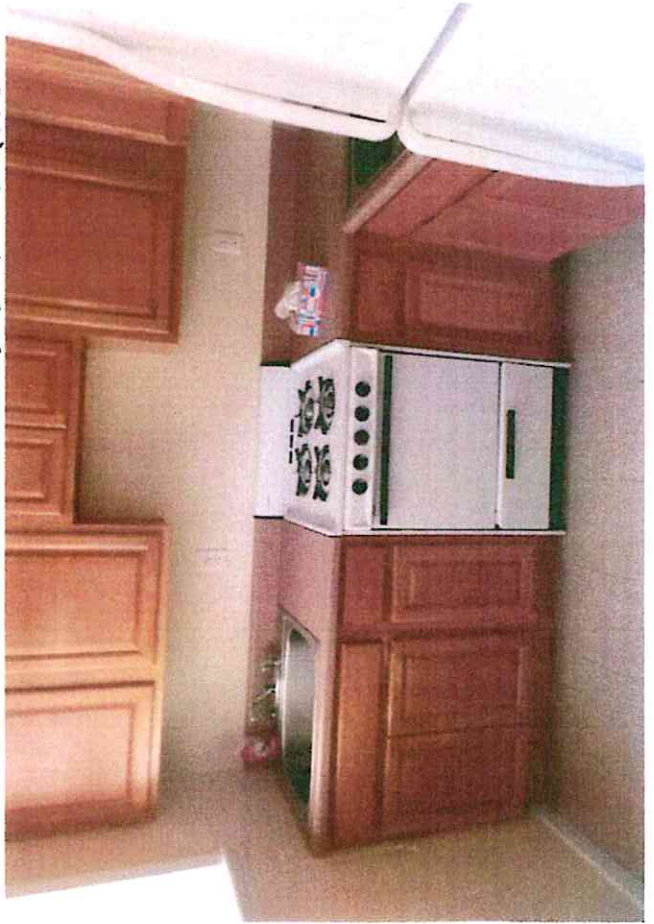
TYPICAL KITCHEN & BATH, UNITS 23/24

Duplex Unit #23/24 – These are both three bedroom, two bath units, along with a kitchen/dining area and washer – dryer connection fitting. A CO monitor is required in both units to supplement the existing smoke detectors. The interior finishes were found to be in excellent condition, well maintained and clean.

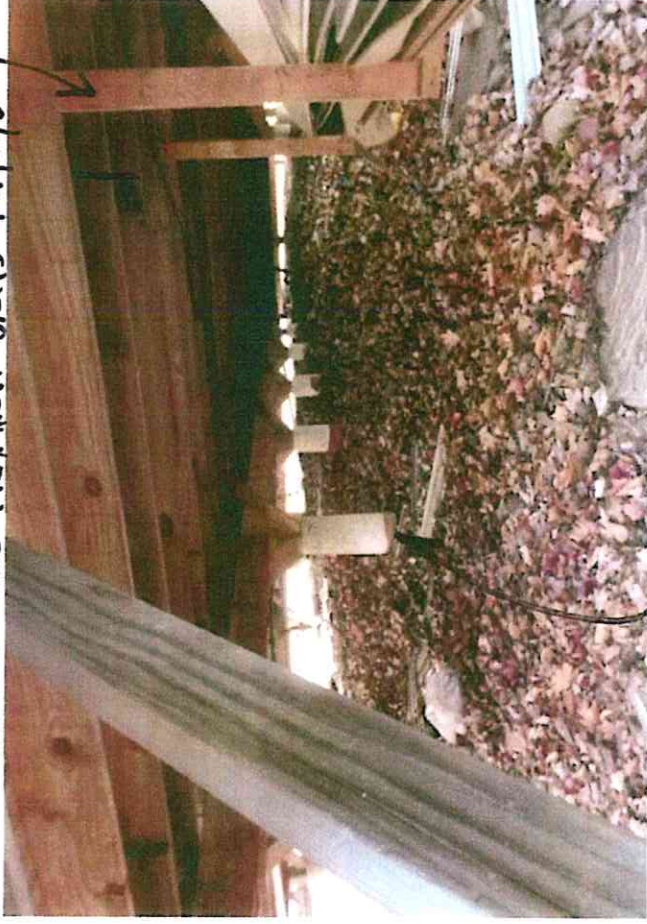
FRONT PORCH 16

CONC. SONOTUBE PIERS

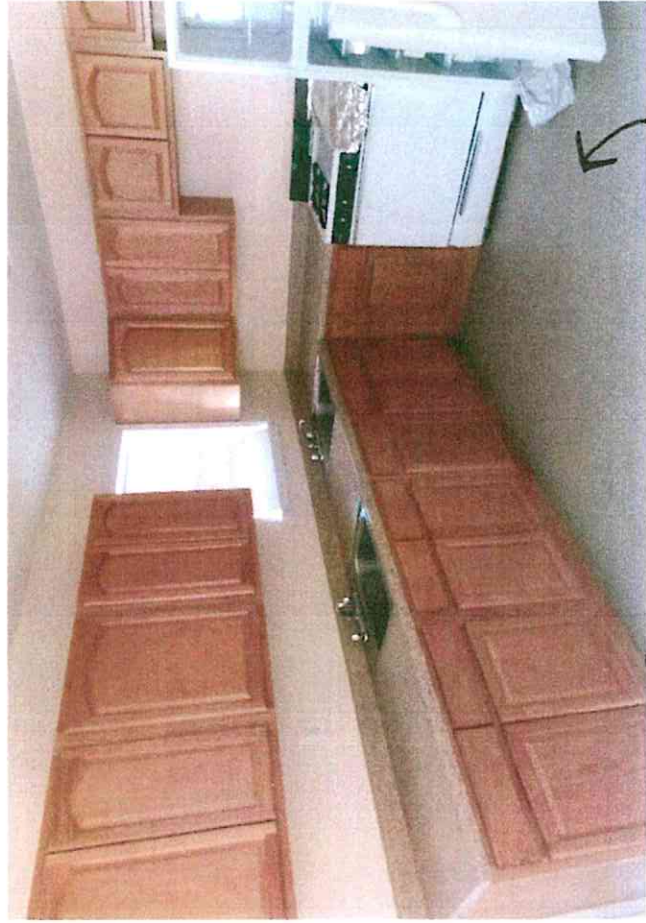
UNIT 15 KITCHEN

Duplex Unit #14/15 – Both of these units also contain two bedrooms and a single bath. They require CO monitors to supplement the existing smoke detectors. The finishes are in excellent condition and well maintained. The overall structure is in good condition.

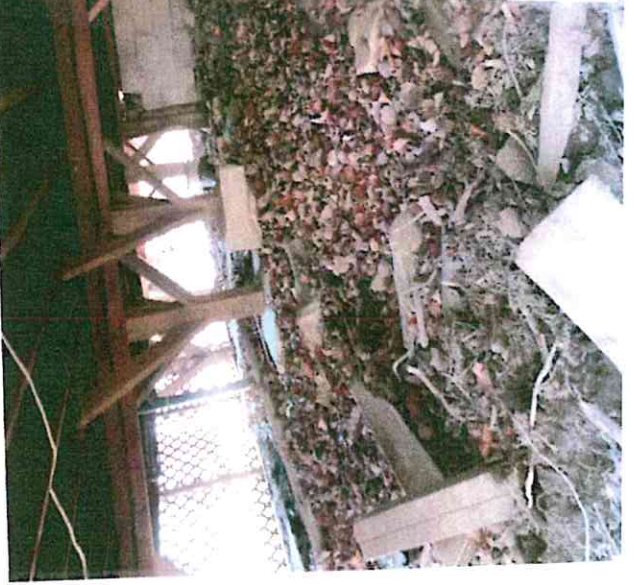
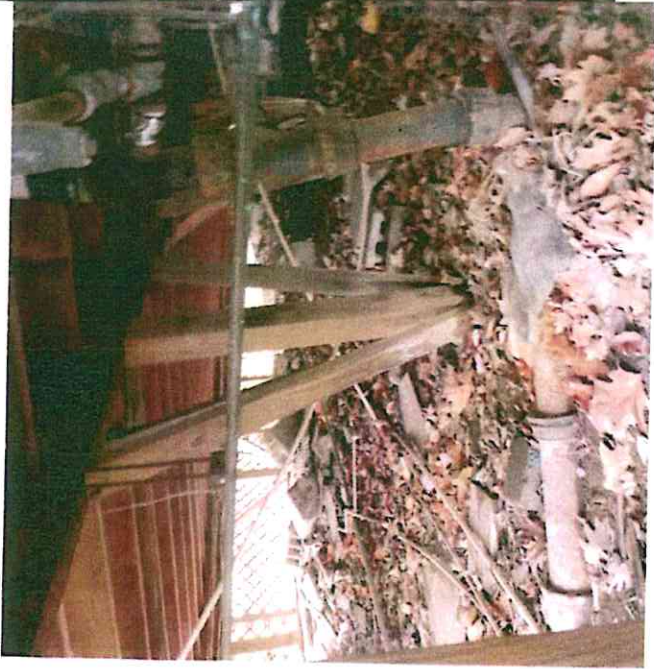
UNIT 16/17 CRAWLSPACE

Duplex Unit #16/17 – Both units contain two bedrooms and a single bathroom. Crawlspace framing consists of 6" x 6" P.T. wood piers set on 2' x 2' concrete footing pads on grade, it appears that the building is periodically leveled to address for seasonal frost heave. There is an original concrete block porch foundation that exists below the front porch in the crawlspace area, although the current building was basically constructed over that structure with only two front 6" x 6" wood support piers at the porch set on the original concrete steps. The crawlspace wood framing appears to be in satisfactory condition and solid.

TYPICAL CRAWLSPACE (UNIT 16/17)

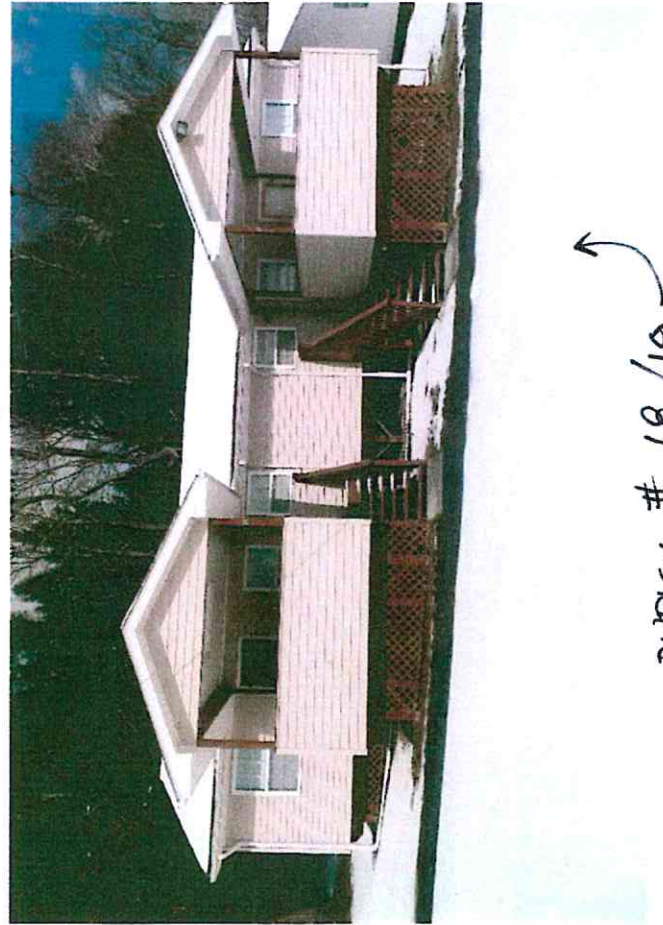
↑ DUPLEX # 18/19

Duplex Unit #18/19 – Each of these units contain three bedrooms and two bathrooms. The finishes were found to be in excellent condition, well maintained and clean. One bedroom in unit #19 is missing a cover on the electrical receptacle which needs to be installed.

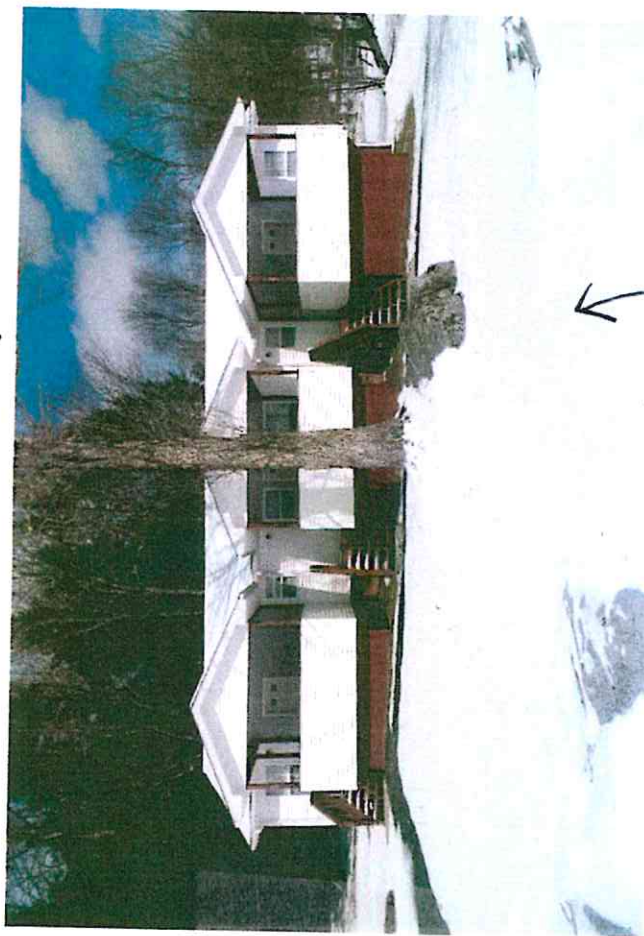
TRIPLEX # 20/21/22

Triplex Unit #20/21/22 – All three units contain two bedrooms and one bath each. The ceiling light fixture in the dining area is quite loose and requires repair. The interior finishes are in excellent condition.
